# Manhole Inspection Summary

Manhole # S27A\_\_027MH

Insp Date: **11/30/07 12:01 PM**

**Location** Address: **BEHIND 907 HARLEM AVE**

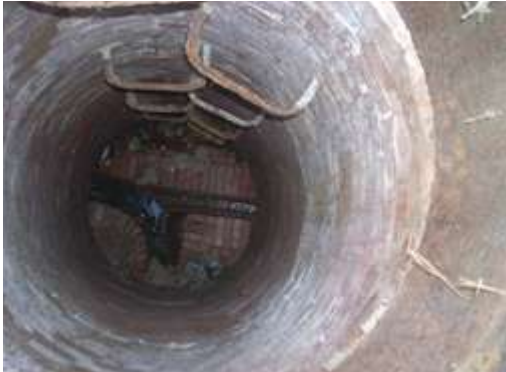
Defect 1

Count: **9** Missing: **0** ☒ **Corroded**

CORRODED STEPS

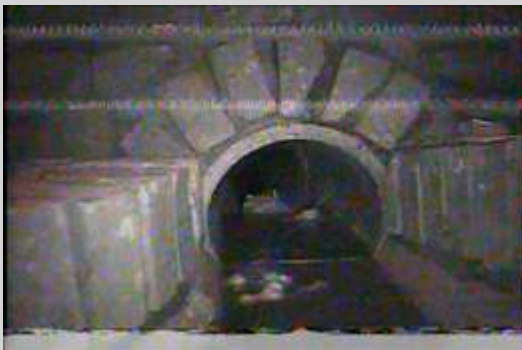
12 O'Clock Outflow

8 in. Circular Gravity Sewer  
Pipe Out @ 12 O'Clock

Pipe Height: **8.4** (in.) Rod and Bar (Angled)  
Pipe Material: **Clay** ☐ Pipe Lined  
Invert Depth: **13.05** (ft.) Flow Characteristics: **Slow**  
Deposits: ☐ None ☐ Mud ☐ Gravy ☒ Debris ☐ Grease  
Silt Depth: **1** (in.) Deposits Extent: **Light**  
Infiltration: **None** Pipe Seal Cond: **Sound**

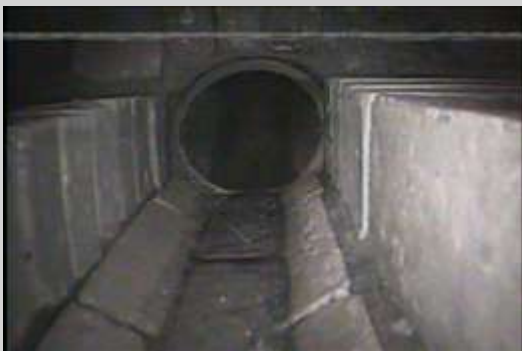
6 O'Clock Inflow

6 in. Circular Gravity Sewer  
Pipe In @ 6 O'Clock

Pipe Height: **6** (in.) Rod and Bar (Angled)  
Pipe Material: **Clay** ☐ Pipe Lined  
Invert Depth: **12.77** (ft.) Flow Characteristics: **Slow**  
Deposits: ☒ None ☐ Mud ☐ Gravy ☐ Debris ☐ Grease  
Silt Depth: (in.) Deposits Extent:  
Infiltration: **None** Pipe Seal Cond: **Sound**

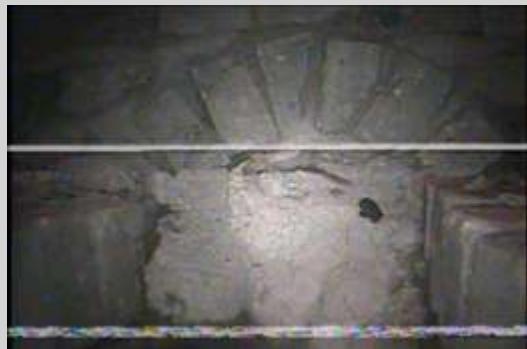
9 O'Clock Inflow

8 in. Circular Gravity Sewer

Deposits: ☐ None ☒ **Mud** ☒ **Sludge** ☐ Debris ☐ Grease

Silt Depth: **8** (in.) Deposits Extent: **Heavy**
